Special Report 82-33

Cold Regions Research &
Engineering Laboratory

Infrared inspection of new roofs

Charles J. Korhonen

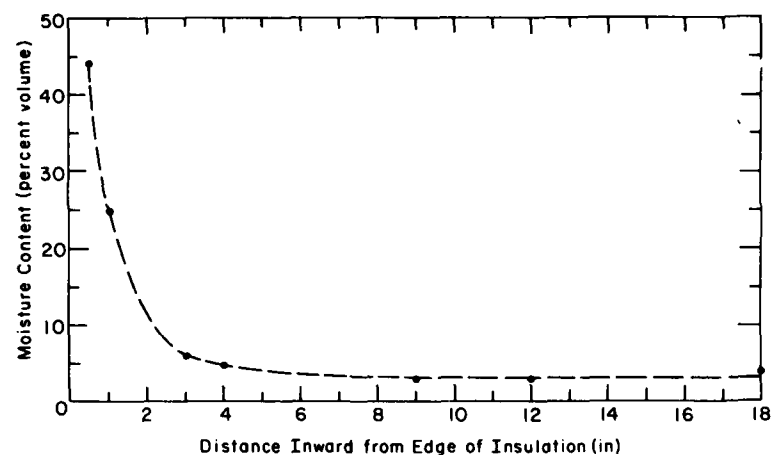
Figure 5. Relationship between moisture content and the distance away from the edge of a board of urethane insulation shown in Figure 3.⁹

that the volumetric water content dropped from over 40% near the edge of the board to 10% about 2 inches into the board (that moisture would have been distributed more uniformly in a fibrous insulation).

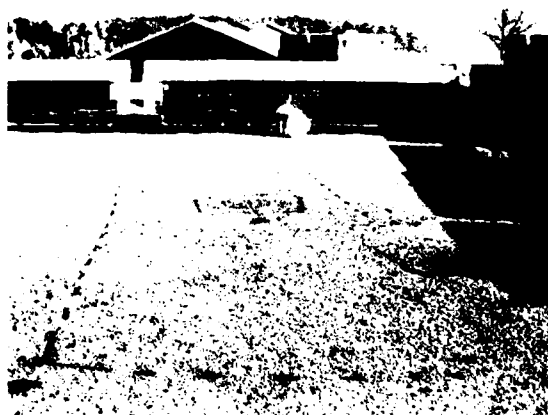
c. October 1979 photograph. The solid spray-painted lines depict the extent of wet insulation detected in May while the dotted lines depict the October boundaries.
